Revised SCOPE OF WORK  
SHIPYARD MAINTENANCE TASKS  
OF THE SURVEY VESSEL LINTHICUM

### ULTRA SONIC INSPECTION REPORT OF THE "LINTHICUM"

PERFORMED FOR  
United States Army Corps of Engineers  
2611 Leahy Street  
Baltimore, MD 21230

May 30, 2003

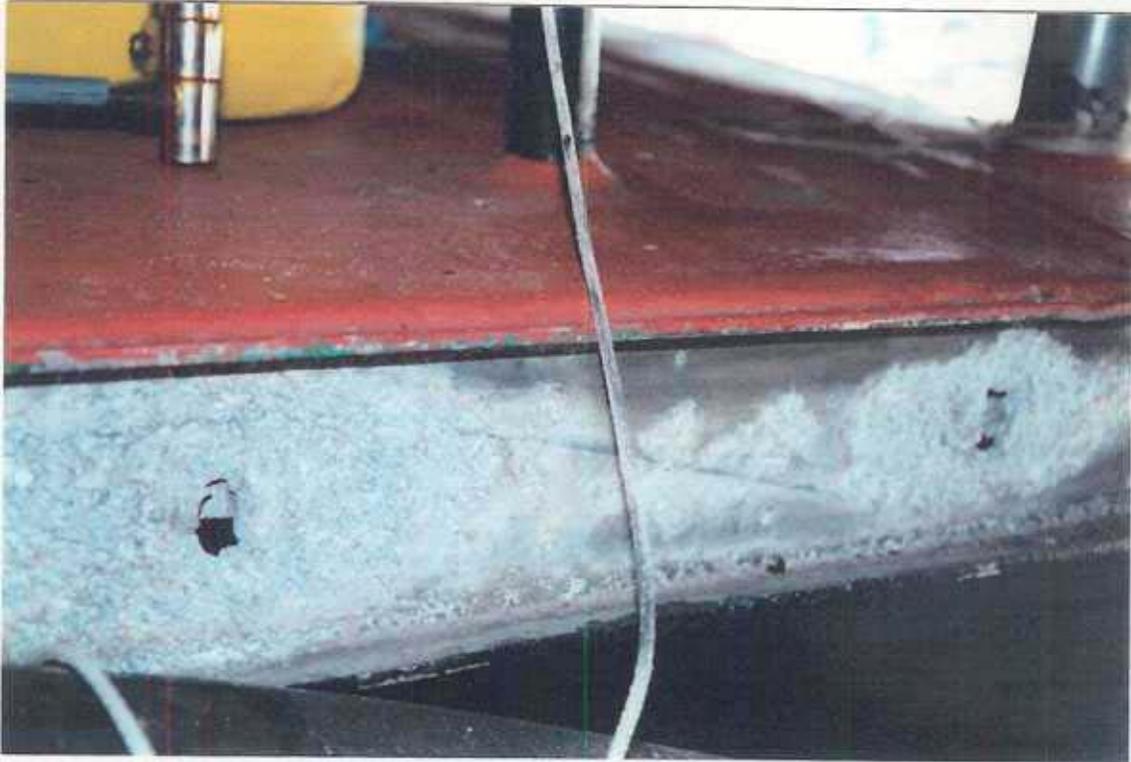
**Rub Rail Port Aft Quarter**

The port and starboard rub rails were also inspected and the aluminum backing plate is badly deteriorated, requiring removal and replacement of the aluminum backing plate.

- At a minimum the area on the starboard side of the vessel, six feet forward of the transom should be cut away and new plate installed. This area was identified with black marker during the inspection of the hull on May 30<sup>th</sup> and is approximately 20" x 18" in size.
- Remove (cut away) the short sections of aluminum pipe at the head discharge and generator intakes under the flexible hose. Clean the cut end of the pipe to remove any sharp edges, install new flexible hose and double clamp.
- Disassemble the generator and head seacocks (a total of four valves), clean away any corrosion, paint the steel valve bodies, replace insulating gaskets with new, re-install and lubricate.
- Cut away the corroded aluminum rub rail backing plate. Re-install a new aluminum backing plate by mechanically fastening the backing plate or rub-rail to the vessel.

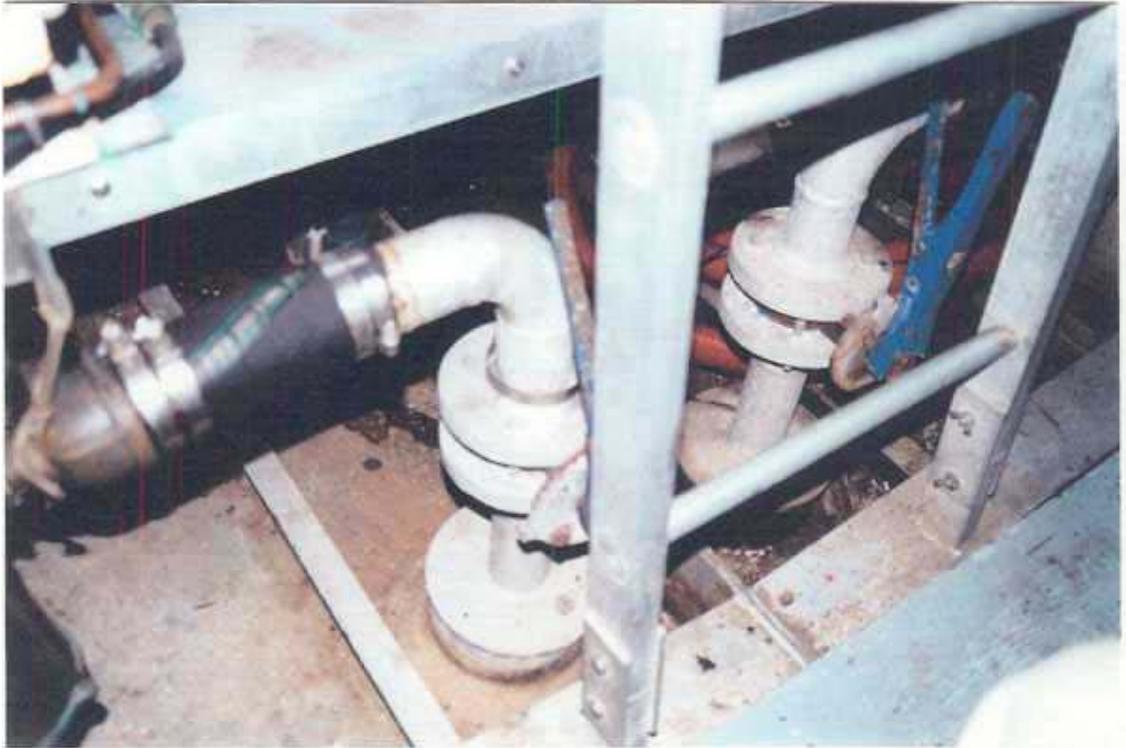
**Generator Saltwater Intakes**

The aluminum saltwater piping for the head and two Onan generators was also inspected and appeared to be in good condition with the exception of the short areas under the flexible hoses. These areas showed evidence of pitting. In addition, the four valves (head intake, head discharge and generator saltwater intakes) showed evidence of minor corrosion. The valves should be disassemble, cleaned, steel valve bodies painted and the valves lubricated.

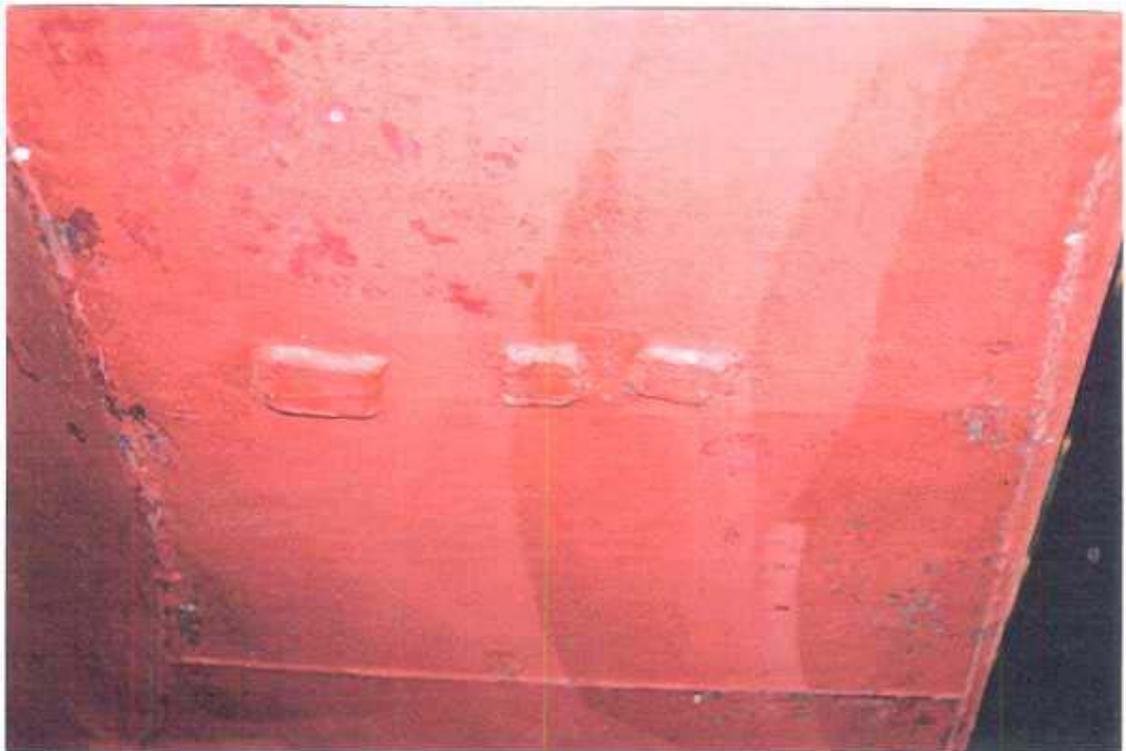
**Doubler Plates Starboard Aft**

One area was identified as having thin or deteriorated plating. This area was to starboard and at the three small doubler plates. The plating at the two transducers (port) should also be inspected further by removing the transducers.
